March 17, 2025

File: 025025

RE: SLOPE STABILITY ASSESSMENT
EXISTING SINGLE FAMILY DWELLING
PROPOSED DECKS REPLACEMENT
51 HURD STREET, KEMPTVILLE
MUNICIPALITY OF NORTH GRENVILLE, ONTARIO

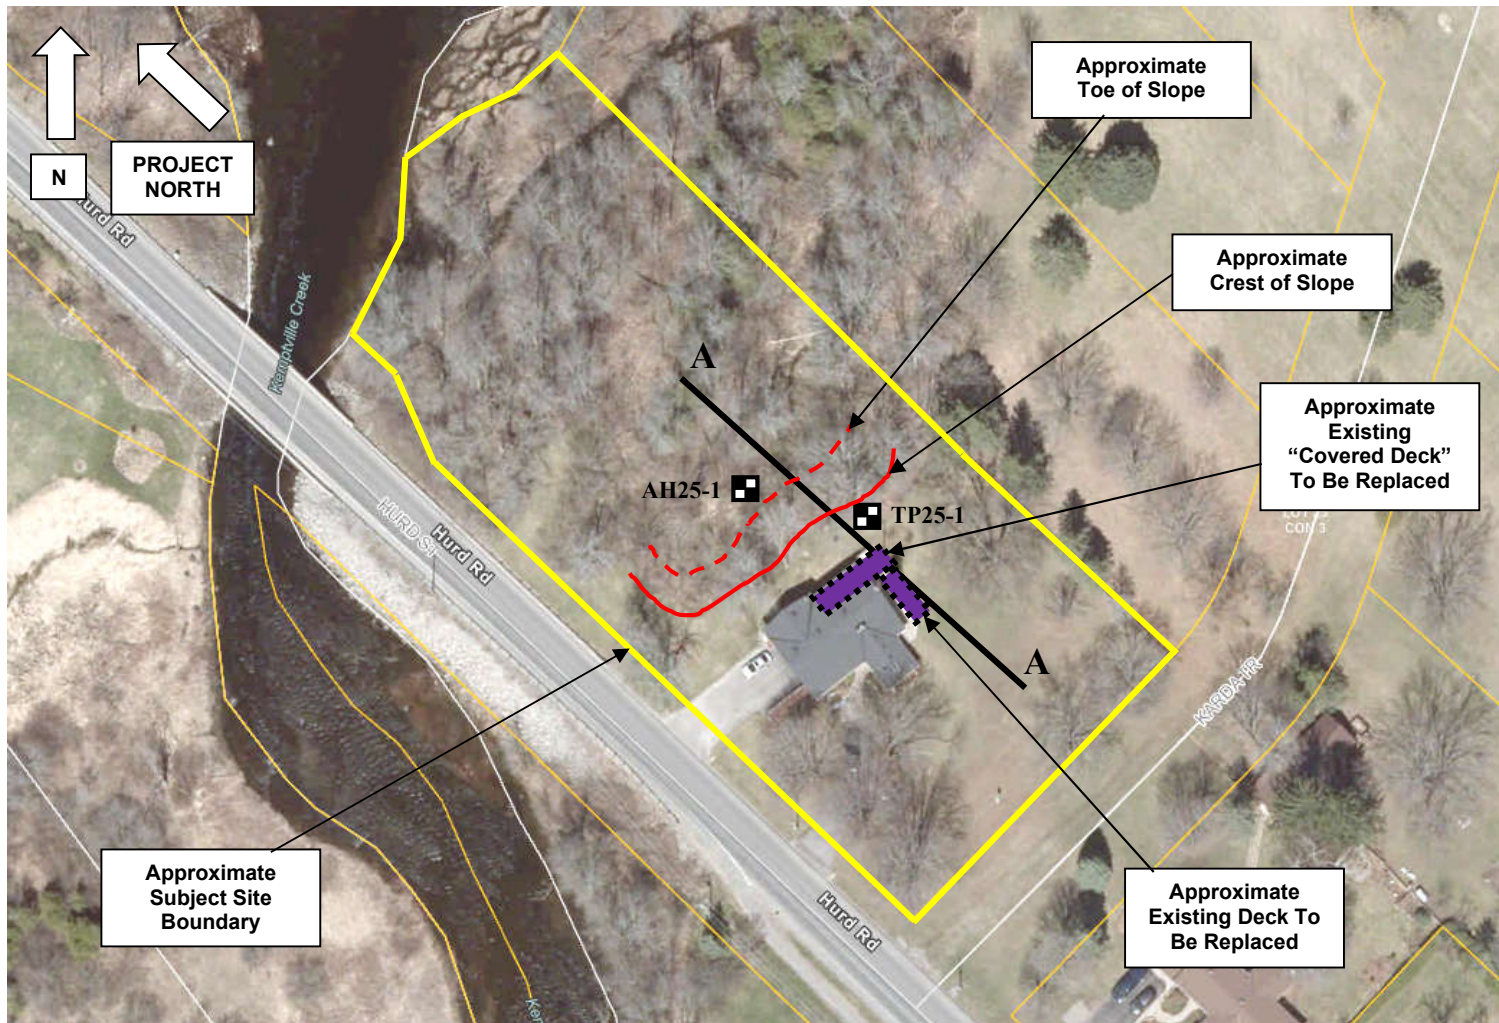
FIGURE 2

Computer slope stability analyses were carried out for what is considered the steepest/highest portion of the subject slope at the site using GeoStudio 2018 Slope/W software package produced by GEO-SLOPE International Ltd., in order to determine a factor of safety of the slope against overall rotational failure (global slope stability analysis). The slope section used in the analyses was chosen by Morey Associates Ltd. based on slope geometry, slope height and the location of the slope section relative to the proposed replacement decks at the site. The approximate location of the slope section analyzed (A-A) is shown on the attached Aerial Sketch Plan, Figure 2.

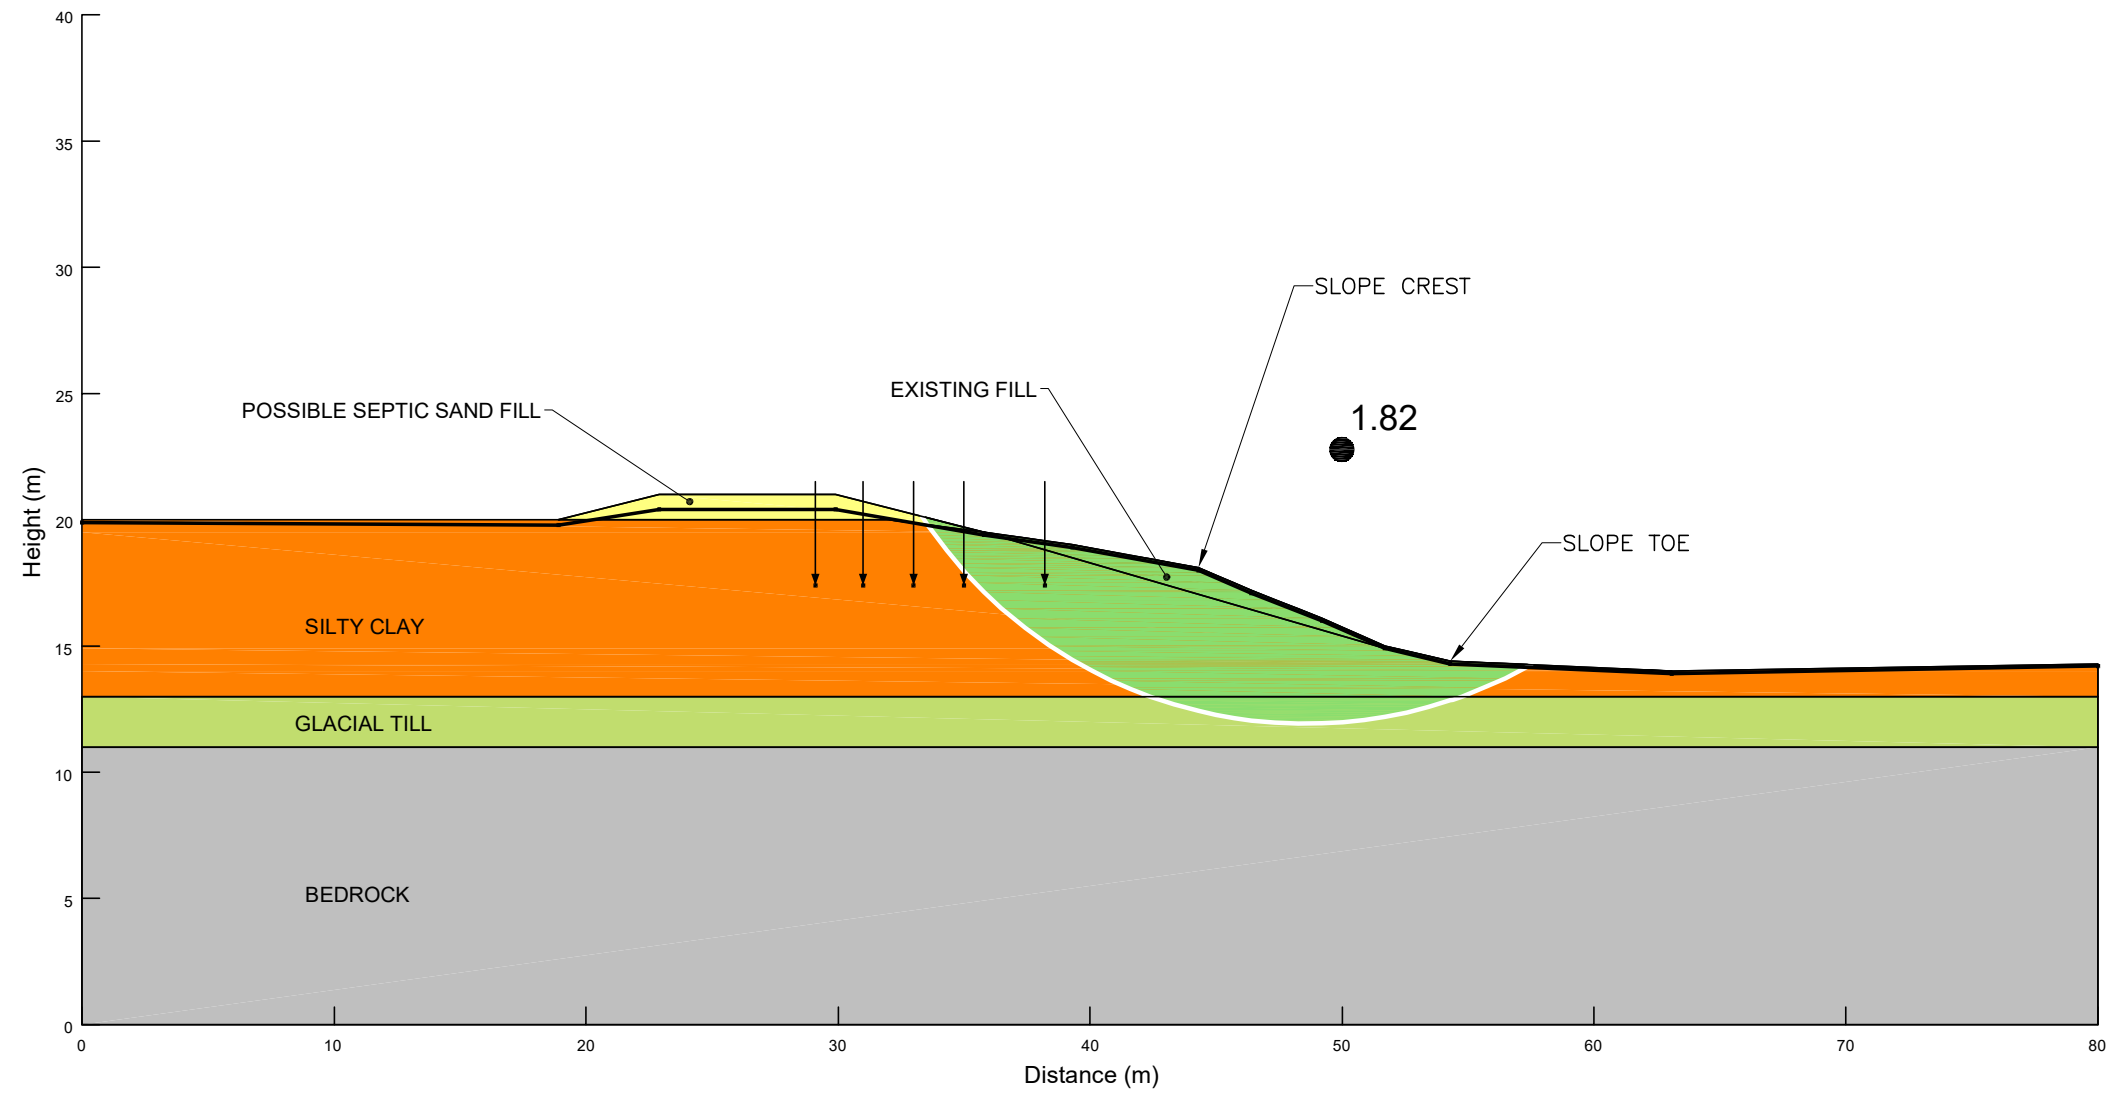
ANALYSIS NAME	STATIC CONDITIONS - SLOPE SECTION A-A FIGURE 5
LOCATION	51 HURD STREET MUNICIPALITY OF NORTH GRENVILLE ONTARIO

The result of the slope stability analysis for the subject slope for static conditions at the slope section analyzed indicates that the slope has a factor of safety against failure of about 1.8, see attached Figure 5. The result of the slope stability analysis for the subject slope for pseudo-static conditions at the slope section analyzed indicates that the slope has a factor of safety against failure of about 1.2, see attached Figure 6.

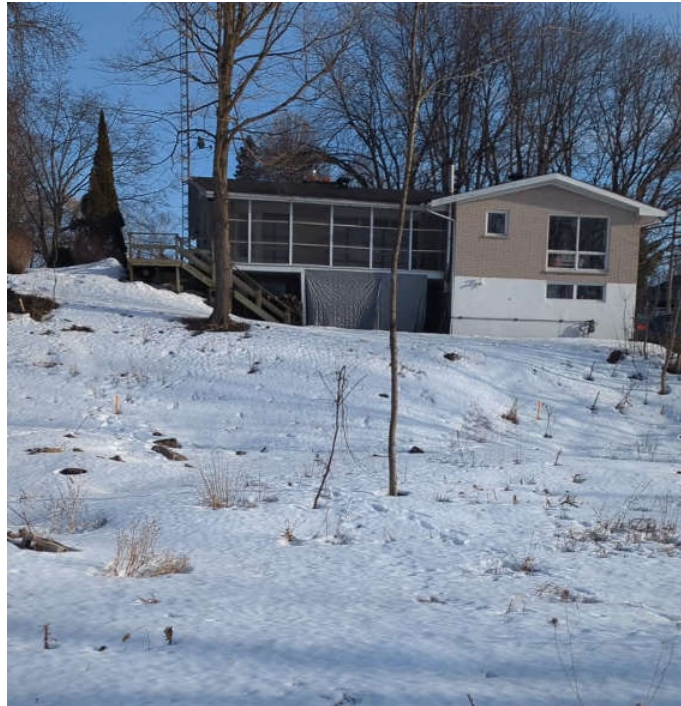
No evidence of major slope instability was observed at the time of the field work. No evidence of active or previous erosion at the subject slope toe was observed. The Kemptville Creek was measured to be some 60 metres from the subject slope toe.

Photograph 1: Subject slope with existing dwelling/covered deck in background, floodplain in foreground.
[Looking in project south direction]

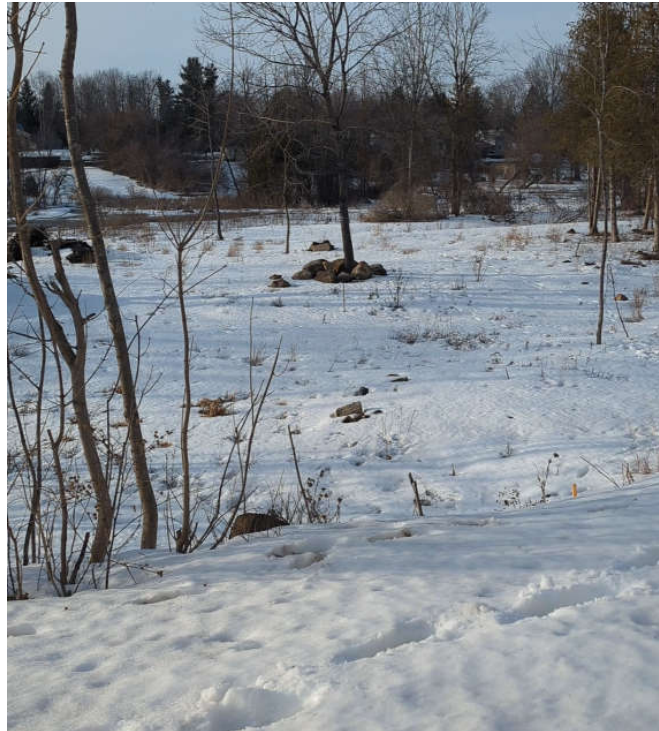
Photograph 2: Crest of subject slope in foreground, floodplain in background with Kemptville Creek beyond.
[Looking in project north direction]

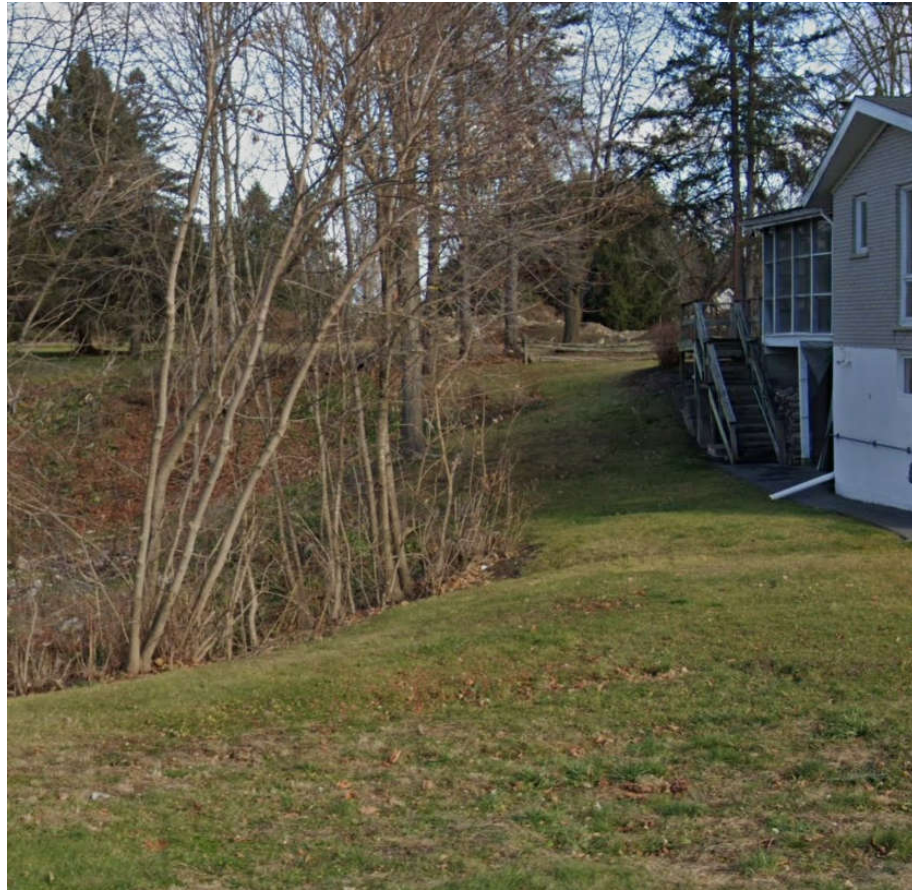
Photograph 3 [Google Street View Webiste – Nov.2024]: Existing dwelling/covered deck and subject slope
[Looking in project east direction]
