March 14, 2025

File: 024634

RE: SLOPE STABILITY ASSESSMENT  
EXISTING SINGLE FAMILY DWELLING – PROPOSED ADDITION AND SHED  
116 CLOTHIER STREET EAST, KEMPTVILLE  
MUNICIPALITY OF NORTH GRENVILLE, ONTARIO

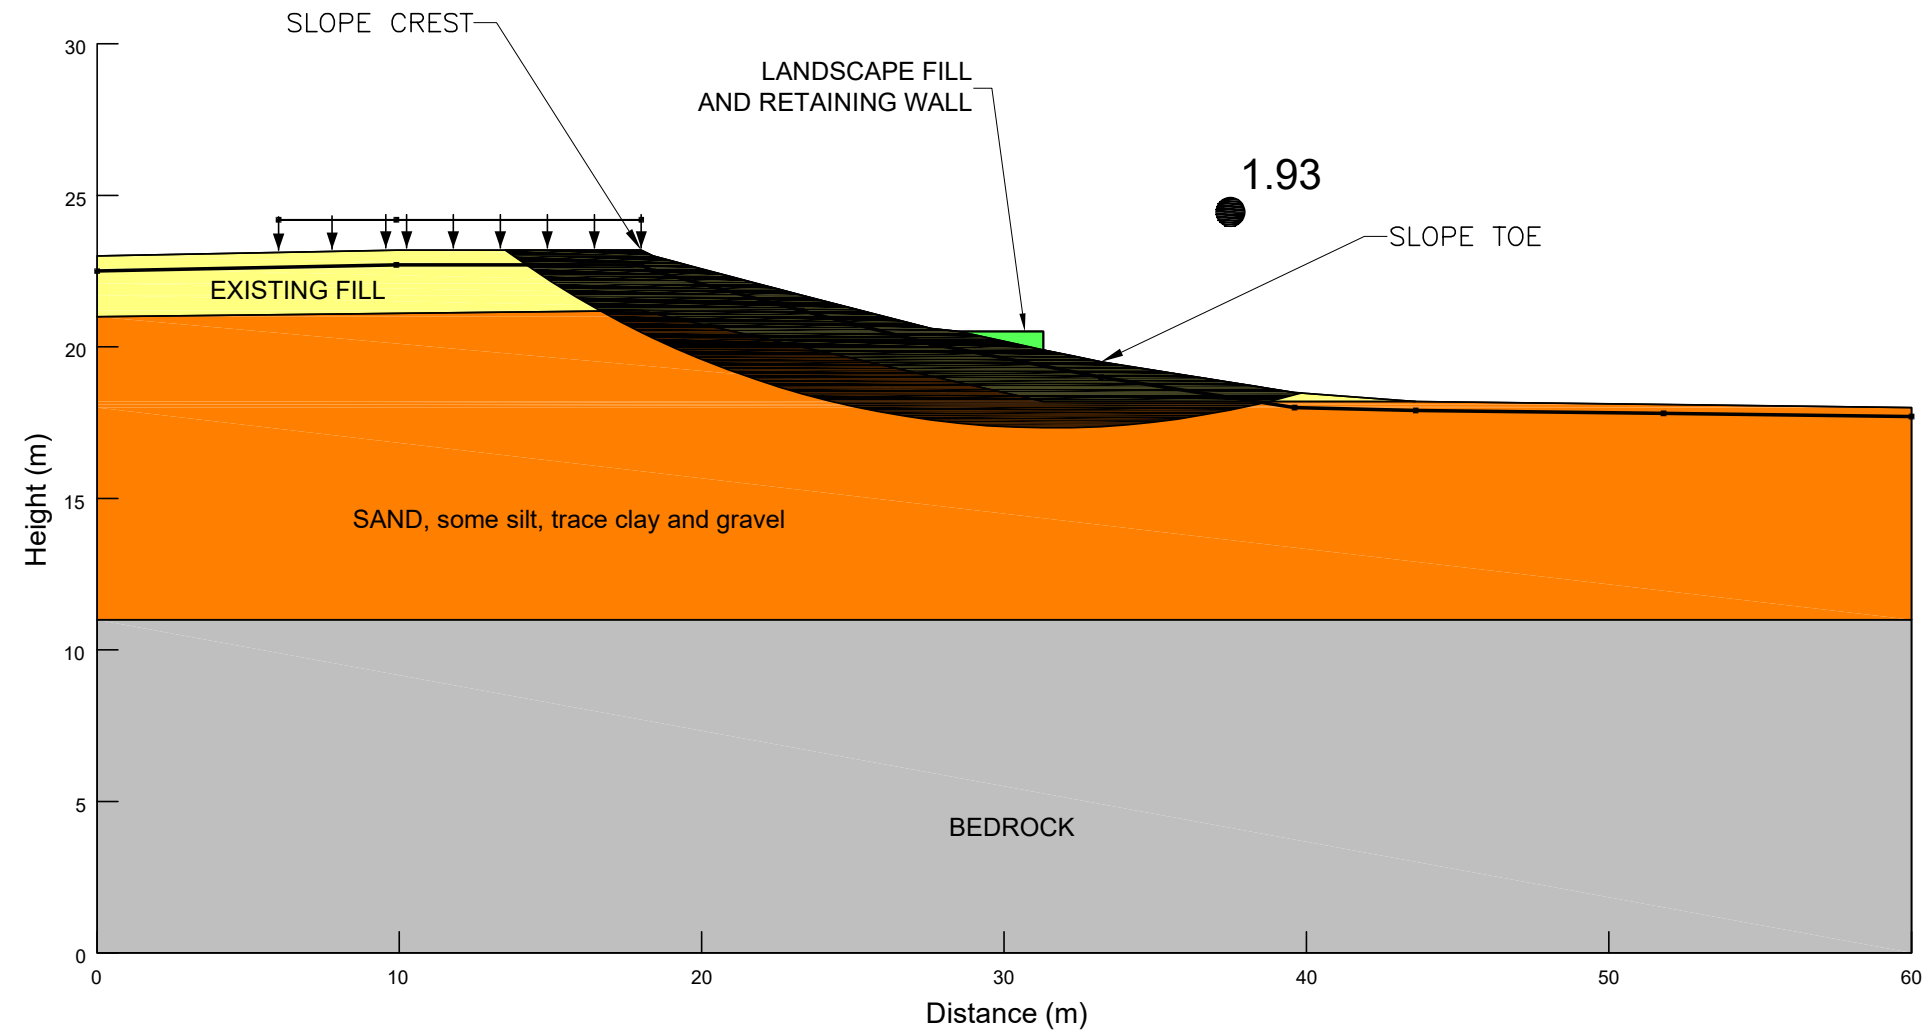
ANALYSIS NAME	STATIC CONDITIONS - SLOPE SECTION A-A FIGURE 5
LOCATION	116 CLOTHIER STREET EAST MUNICIPALITY OF NORTH GRENVILLE ONTARIO

The result of the slope stability analysis for the subject slope for static conditions at the slope section analyzed indicates that the slope has a factor of safety against failure of about 1.93, see attached Figure 5. The result of the slope stability analysis for the subject slope for pseudo-static conditions at the slope section analyzed indicates that the slope has a factor of safety against failure of about 1.13, see attached Figure 6.

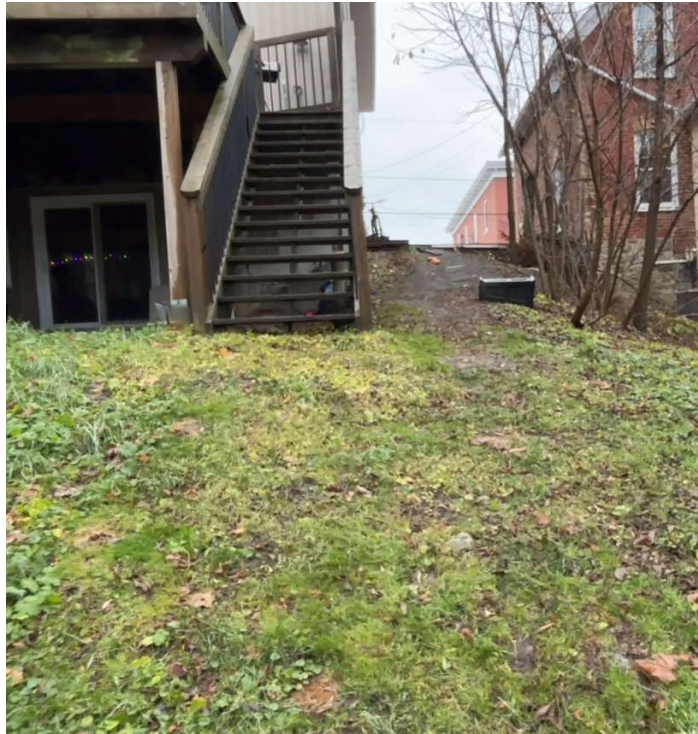
No evidence of major slope instability was observed at the time of the field work. No evidence of active or previous erosion at the subject slope toe was observed. The Kemptville Creek was measured to be some 69 metres from the subject slope toe.

**Photograph 1:** Upper portion of subject slope in background (east side yard), bottom portion of subject slope in foreground (rear yard).  
[Looking in project north direction]

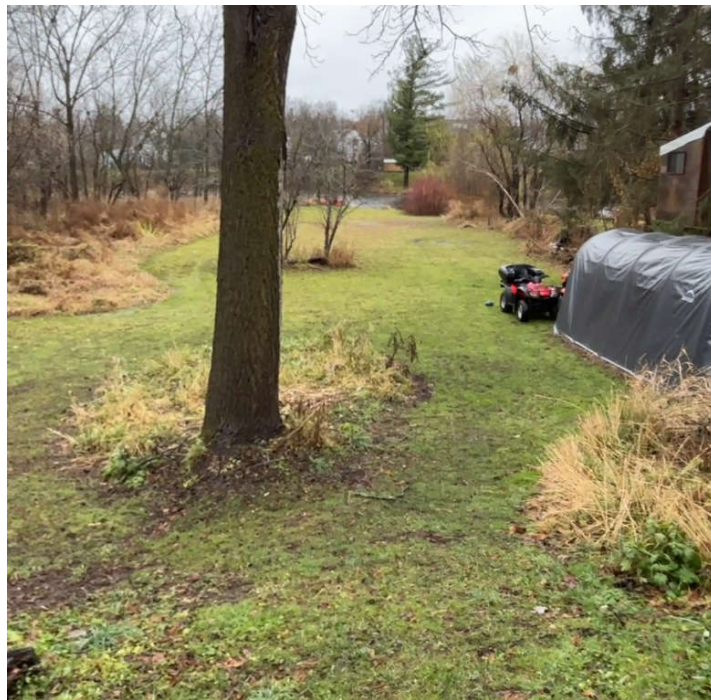
As previously mentioned, the toe of the slope is some 69 metres from the Kemptville Creek. No evidence of active or previous erosion at the subject slope toe was observed at the time of the field work. Based on the observations made at the time of the field work and on the subject site setting it is considered that the subject slope toe is not located in an area prone to toe erosion. Based on the above, it is considered that no significant future erosion should occur at the slope toe of the subject slope. Based on the above no toe erosion allowance for the subject slope is required.

**Photograph 2:** Toe of subject slope in foreground, floodplain in background with Kemptville Creek beyond.  
[Looking in project south direction]
